ULTRASONIC PLY-BY-PLY DETECTION OF MATRIX CRACKS IN
LAMINATED COMPOSITES

A Thesis

Major Subject: Aerospace Engineering

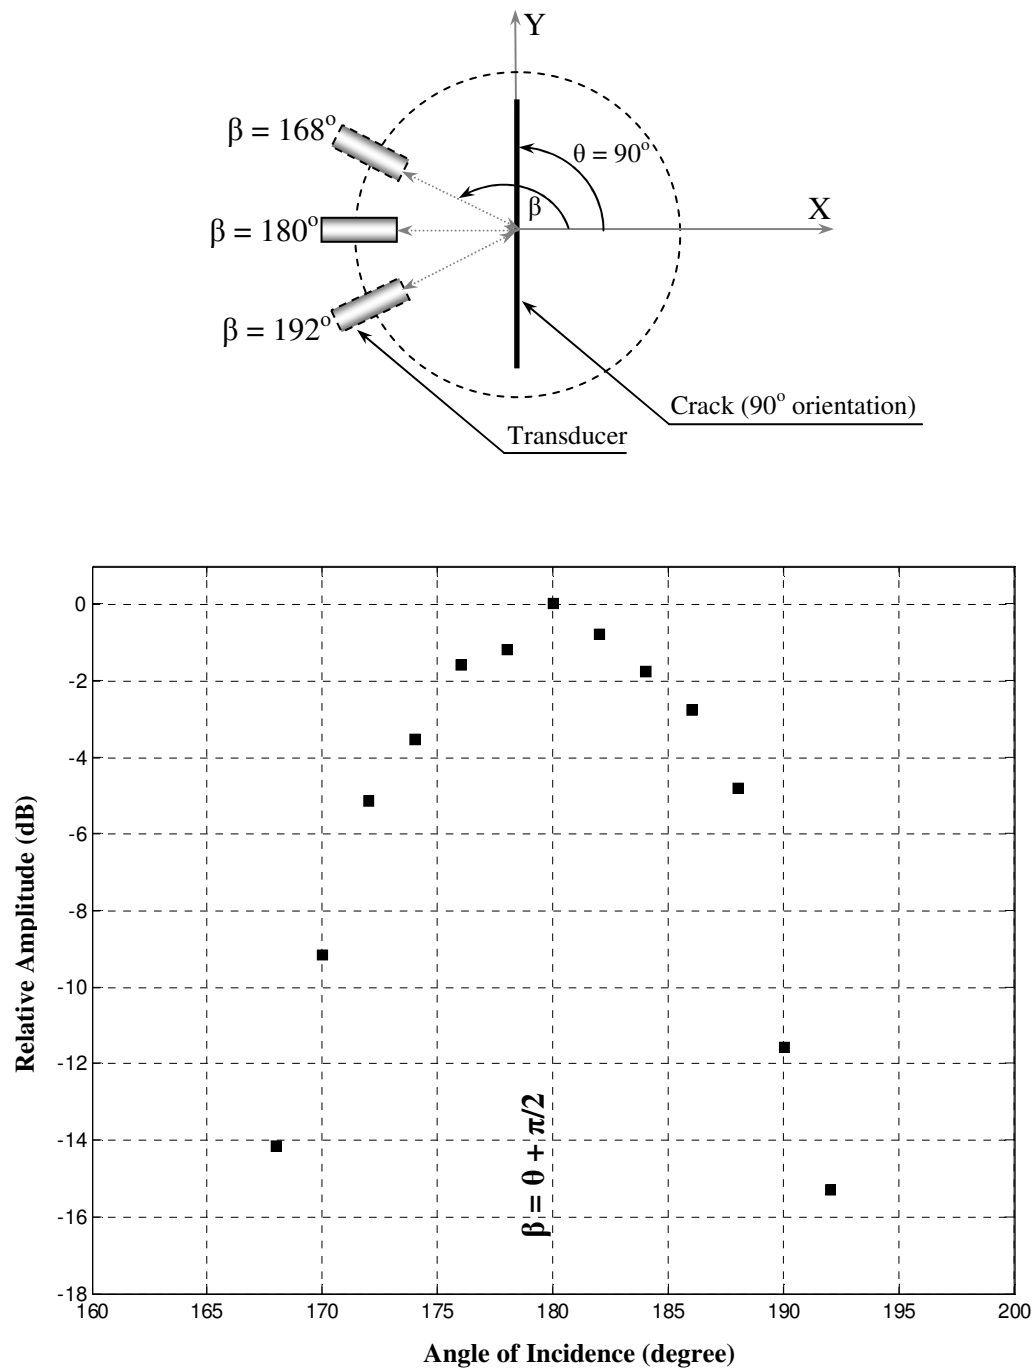
Fig. 2.13 Variation in the amplitude of the reflected signal with changes in the azimuthal angle (β).

angle of incidence as measured from the normal and let β be the azimuthal angle measured from the X-axis, positive in the counter-clockwise direction. To determine the angle β at which the received signal is maximum, a small area of a specimen containing cracks was initially scanned using a transducer adjusted such that the projection of incident ray onto the laminate is perpendicular to the crack faces (i.e. $\beta = \theta \pm \pi/2$). Then, from this position, for a fixed angle of incidence and fixed height above the specimen, the transducer was rotated such that value β varied a few degrees back and forth from the initial adjustment. At each value of angle β , the same area was scanned again and the amplitude of the received signal from a particular crack was plotted. One such plot for a crack in the third ply ($\theta = 90^\circ$) of the 18-ply TAMU-5 specimen is shown in Fig. 2.13. A schematic of the plan view of the experimental arrangement is shown above the plot. The azimuthal angle β was initially set at 180° and varied over a range of $24^\circ (\pm 12^\circ)$ from the initial value, in steps of 2° . The relative amplitude on the y-axis is in decibels and is calculated as

where V is the corresponding absolute amplitude in volt and V_{\max} is the maximum amplitude in volt in a given set of amplitude data. From Fig. 2.13 it is clear that the amplitude of the reflected signal is maximum when the projection of incident ray onto the laminate is perpendicular to the crack faces, i.e. when $\beta = 180^\circ$. This fact was used to generate ultrasonic images of cracks in different plies of a composite laminates. For example, for a simple case of a $[0/90]$ laminate shown in Fig. 2.14, a crack in the first

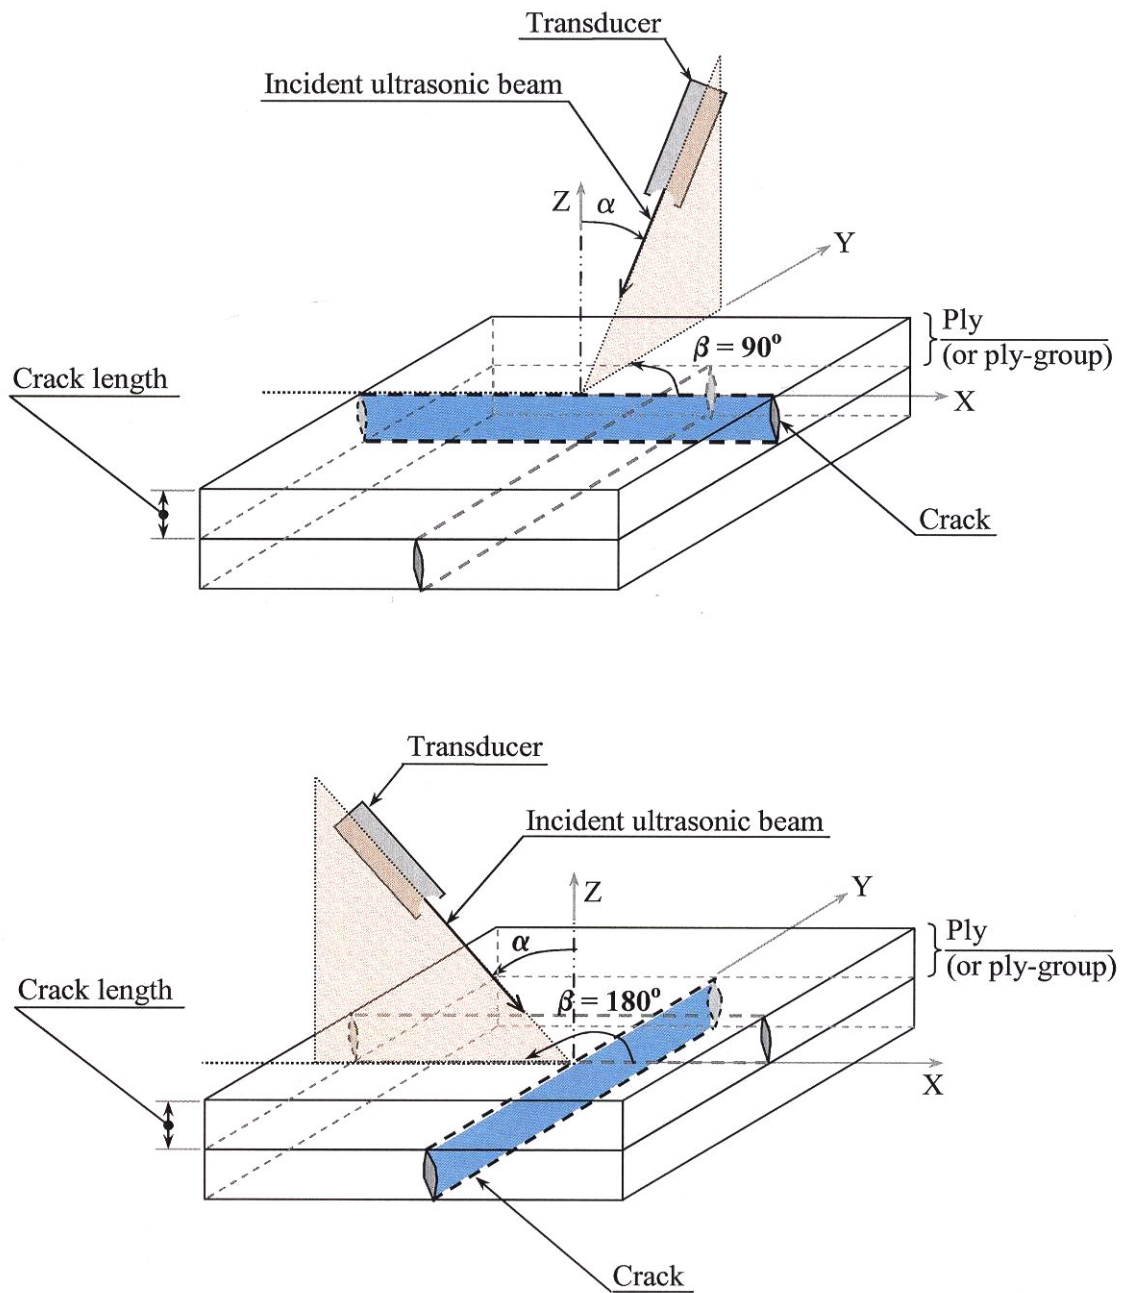
Fig. 2.14 A schematic of the spatial arrangement of the ultrasonic transducer with respect to a cracked ply or ply group. (a) To detect a crack in the first ply (0°), (b) to detect a crack in the second ply (90°).

ply ($\theta = 0^\circ$) can be detected by setting the azimuthal angle $\beta = 90^\circ$ (Fig. 2.14(a)). Similarly a crack in the second ply ($\theta = 90^\circ$) can be detected by setting $\beta = 180^\circ$ (refer Fig. 2.14(b)).

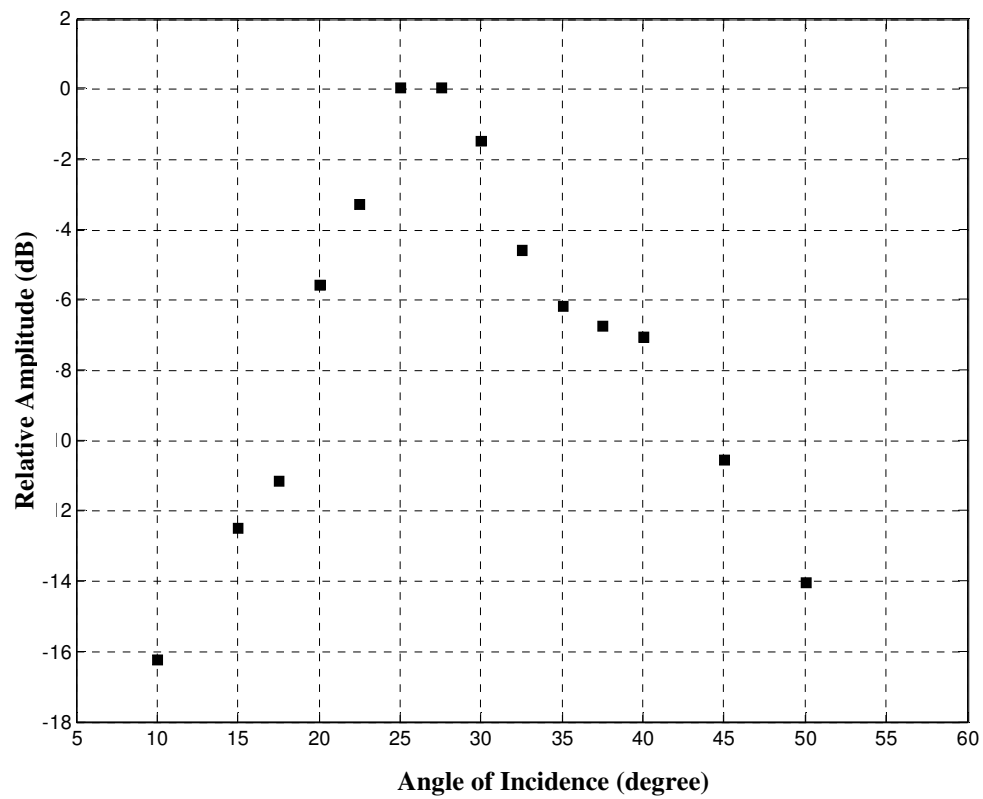
Fig. 2.15 Variation in the amplitude of the reflected signal with changes in the angle of incidence (α).

The angle of incidence α was adjusted such that the amplitude of the signal reflected from the crack, as detected by the transducer, is maximum. To determine this angle experimentally, a small portion of a specimen containing cracks was scanned repeatedly at various angles of incidence. The azimuthal angle β was fixed as explained earlier. For each angle, the height of the transducer was adjusted in such a way the focal spot of the transducer was always coincident with the top surface of the specimen. This ensured that the variations in the reflected signal due to the defocusing the incident beam is avoided. At each angle, the peak amplitude (in volt) of the signal received from a representative crack is plotted; the angle corresponding to the maximum amplitude in this plot is chosen as the angle of incidence. Figure 2.15 shows a plot of relative peak amplitudes of the signal received observed at the corresponding angles of incidence, for a crack in the third ply (90° orientation) of the 18-ply TAMU-5 specimen. The relative amplitude was calculated as explained earlier. From Fig. 2.15 it is clear that the amplitude of the reflected signal is highest at about 25° angle of incidence. However, it may be noted that the amplitude is within 6 dB of the highest amplitude for angles of incidence between 20° and 30° , instructive of the flexibility possible in adjusting the angle of incidence. In this work, all the experiments were conducted with angle of incidence α equal to 25° unless mentioned otherwise.

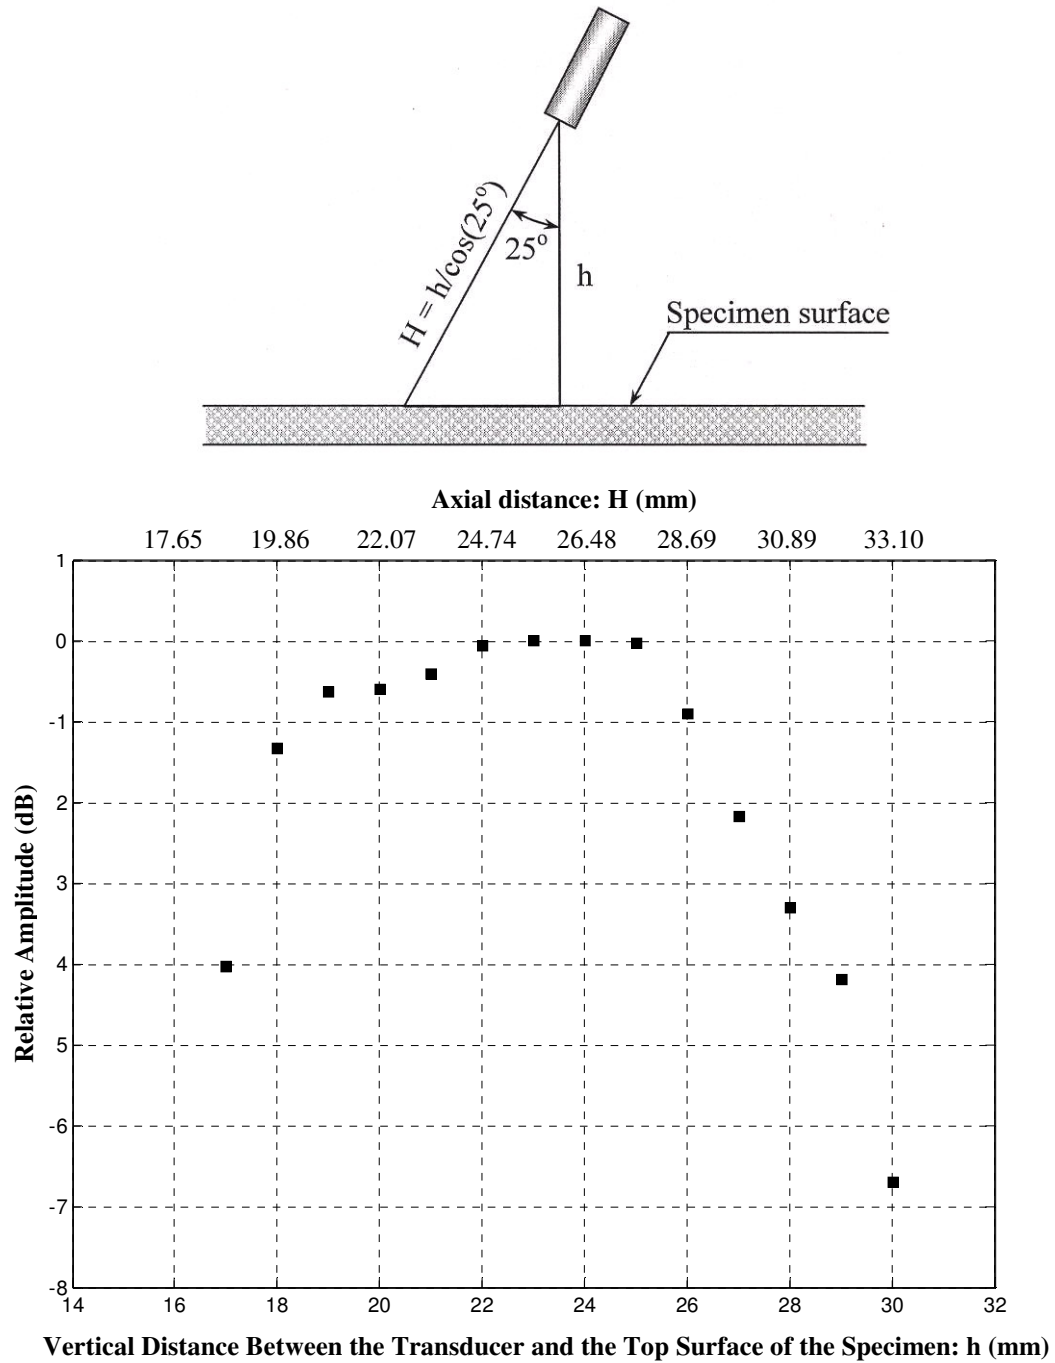
Fig. 2.16 Variation in the amplitude of the reflected signal with changes in the vertical distance between the transducer and the specimen. (Angle of incidence: 25°)

since no data is available to the author's knowledge that will allow theoretical calculation of the change in the focal length when an acoustic beam travels from an isotropic medium to anisotropic medium. This was done by varying the vertical distance between the center of the transducer and the top of the specimen in steps of 1 mm, at a fixed angle of incidence (25° in the present case). At each step, a small area of a specimen containing matrix cracks was scanned and the peak amplitude from a selected crack is recorded. Figure 2.16 shows the variation of the peak amplitude with change in vertical distance between the transducer and the specimen surface. It can be observed that the strength of the reflected amplitude is maximum when the transducer is arranged such that the focal spot is located around the upper surface of the specimen.

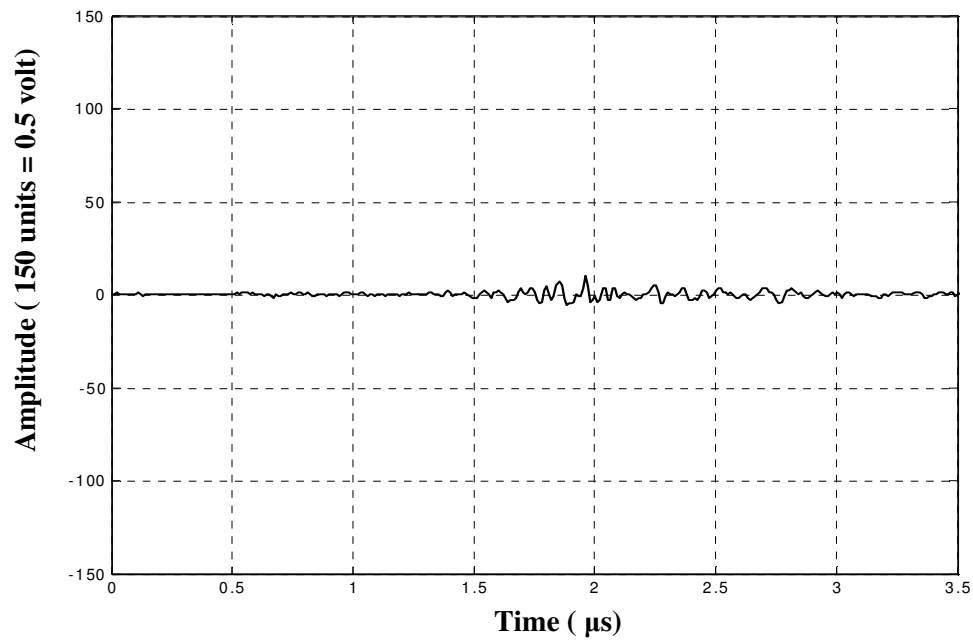
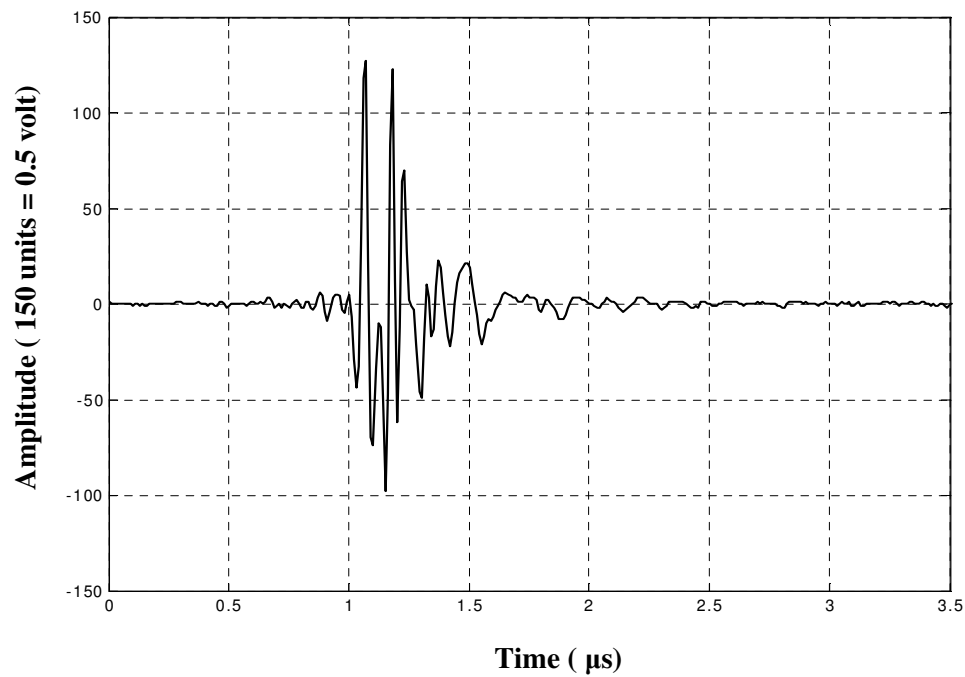
(a) Typical time domain signal in the absence of a crack.

(b) Typical time domain signal in the presence of a crack.

Fig. 2.17 Typical time domain signals observed in case of the TAMU-5 specimen using the polar backscattering technique.

A typical time domain signal *in the absence of a crack* is shown in Fig. 2.17(a). It is seen from Fig. 2.17(a) that the signal received in the absence of a crack is not zero but some small value. This is most likely due to the backscattering of the incident ultrasonic beam by the fibers and/or fiber-bundles [20]. For the same laminate, a typical time domain signal generated by the reflected ultrasonic waves when the incident ultrasonic beam insonifies a matrix crack is shown in Fig. 2.17(b). The signal corresponds to a

crack in the third ply (90° orientation) of the 18-ply TAMU-5 laminate. The backscattered signal by the fibers (seen in Fig. 2.17(a)) is the main contributor towards the noise in the system. However, in most cases reported in this work, the backscattering noise is very weak and the signal to noise ratio was usually found to be above 20 dB indicating a very high level of confidence.

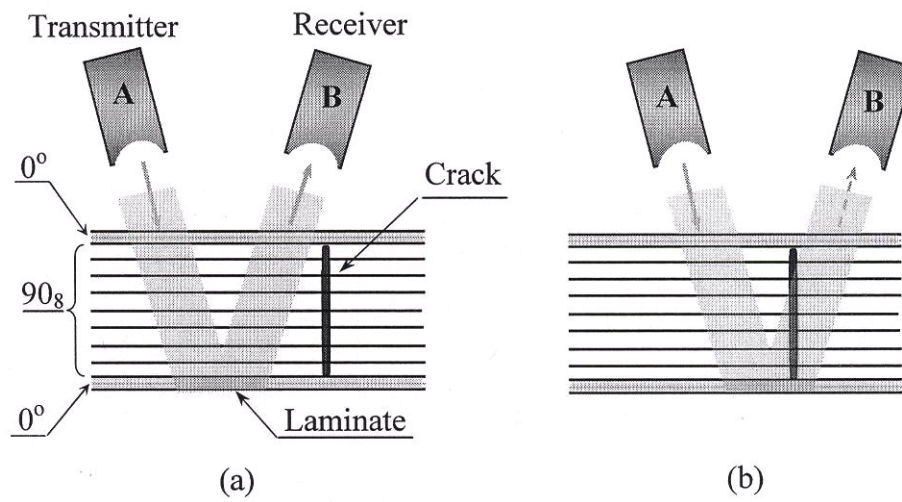
Fig. 2.18 A schematic of the experimental setup for the ultrasonic pitch-catch method. (a) In the absence of a crack, transducer B receives the reflected signal, (b) crack blocks the signal from reaching transducer B.

In the absence of a crack, the reflected signal is detected by the receiver B as illustrated in Fig. 2.18(a). However, when a crack appears in the ‘line-of-sight’ it prevents the reflected signal from reaching the receiver B as shown in Fig. 2.18(b). Consequently, a crack should show up as *a dark band on a bright background*. A typical time-domain representation of the received signals in the absence of crack is shown in Fig. 2.19(a) and that in the presence of a crack is shown in Fig. 2.19(b). As mentioned earlier, in the schematics shown in Figs. 2.19(a) and 2.19(b), the incident and

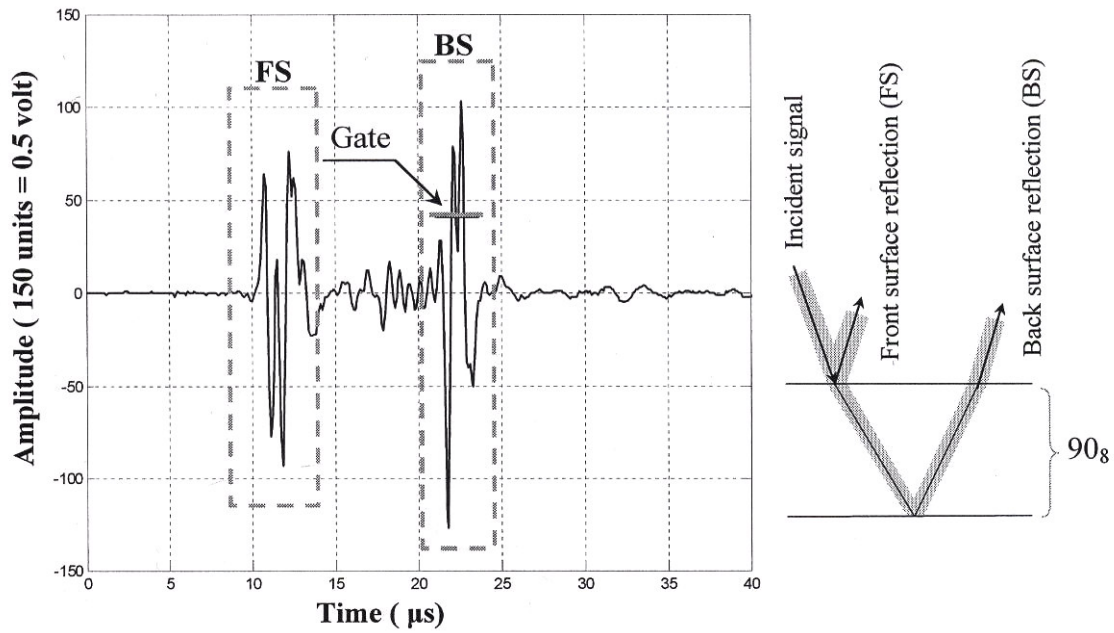
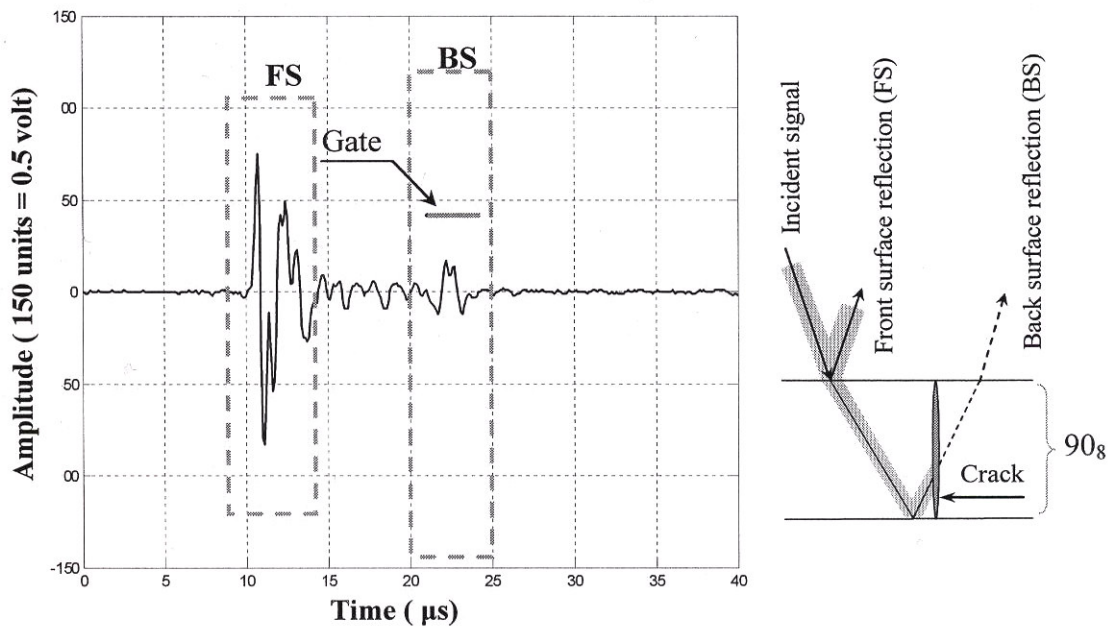
(a) Typical time domain signal in the absence of a crack

(b) Typical time domain signal in the presence of a crack

Fig. 2.19 Typical time domain signals observed in case of the CALB-1 specimen using the pitch-catch technique shown in Fig. 2.16. The transducer is oriented to detect cracks in the 90° ply-group.

the reflected fields are collectively represented by arrows and the shaded area is a symbolic representation of the complicated interaction between the incident beam, the crack and the laminate. As expected, the front surface reflection in the presence of crack (Fig. 2.19(b)) does not show a large variation when compared to that in the absence of crack (Fig. 2.19(a)); whereas, in the presence of a crack, a drastic reduction in the amplitude of the back surface reflection is observed. A 400 ns gate was used to record the changes in the amplitude of the back surface reflection as shown in Figs. 2.19(a) and 2.19(b) and the resulting ultrasonic images are shown in Fig. 2.20(a). The dark bands, as expected, correspond to the cracks. At the same time, in the polar backscattering method, with transducer A acting as the transmitter as well as the receiver, one should expect the cracks to appear *as bright bands on a dark background*. The results are shown in Fig. 2.20(b). Here, the bright bands, as expected, correspond to the cracks. One should not expect to see a sharp line corresponding to a sharp crack because these ultrasonic images are not optical images of a crack in the sense of photography. Instead, these are gray-scale representation of acoustic field received after a rather complex interaction with the crack. A one-to-one correspondence between the images of cracks obtained by using pitch-catch (Fig. 2.20(a)) and polar backscattering (Fig. 2.20(b)) is observed. As an independent corroboration, the edges of the specimen were observed under a microscope at 200X magnification. A schematic of the optically detected cracks (Fig. 2.20(c)) is included at the bottom of the Fig. 2.20(b). It is reassuring to note that there is a one-to-one correspondence between the optical data and the ultrasonic data.

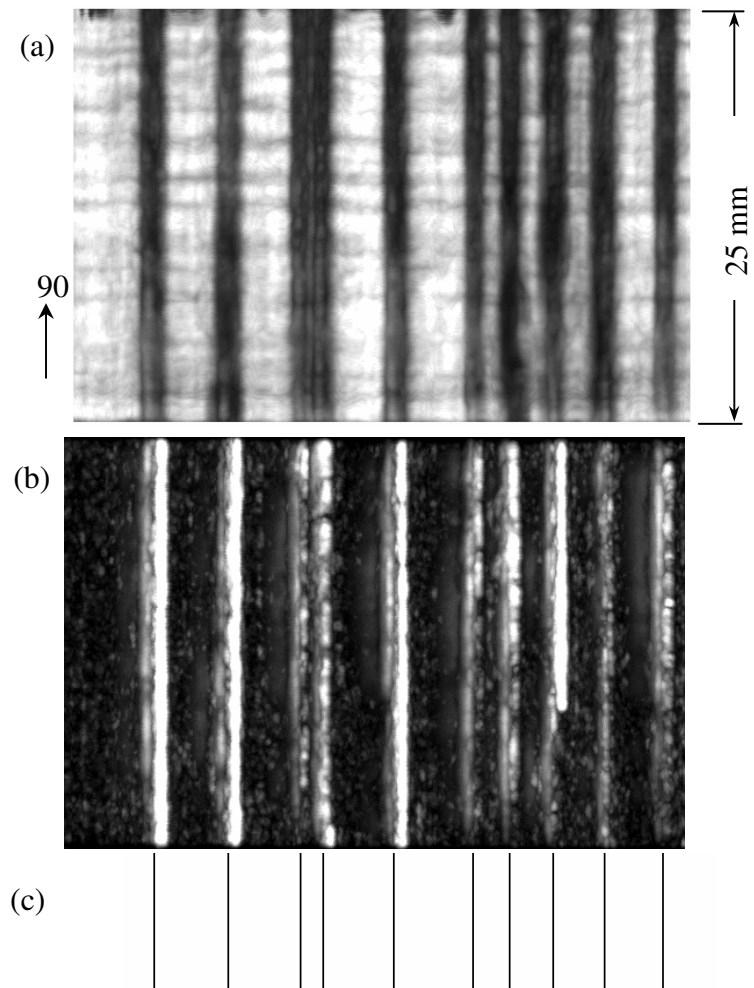
Fig. 2.20 Ultrasonic images of matrix cracks in the $[0/90_4]_s$ CALB-1 laminate. (a) pitch-catch method, (b) polar backscattering, (c) schematic of the optically detected cracks at the edge of the specimen.

It is well known that wave propagation in laminated composites is an extremely complex phenomenon [28-30]. Nevertheless, some attempts were made theoretically model the experimental results reported in Fig. 2.20; these attempts were largely unsuccessful. The knowledge gained during the exercise is documented in the appendix for future use.

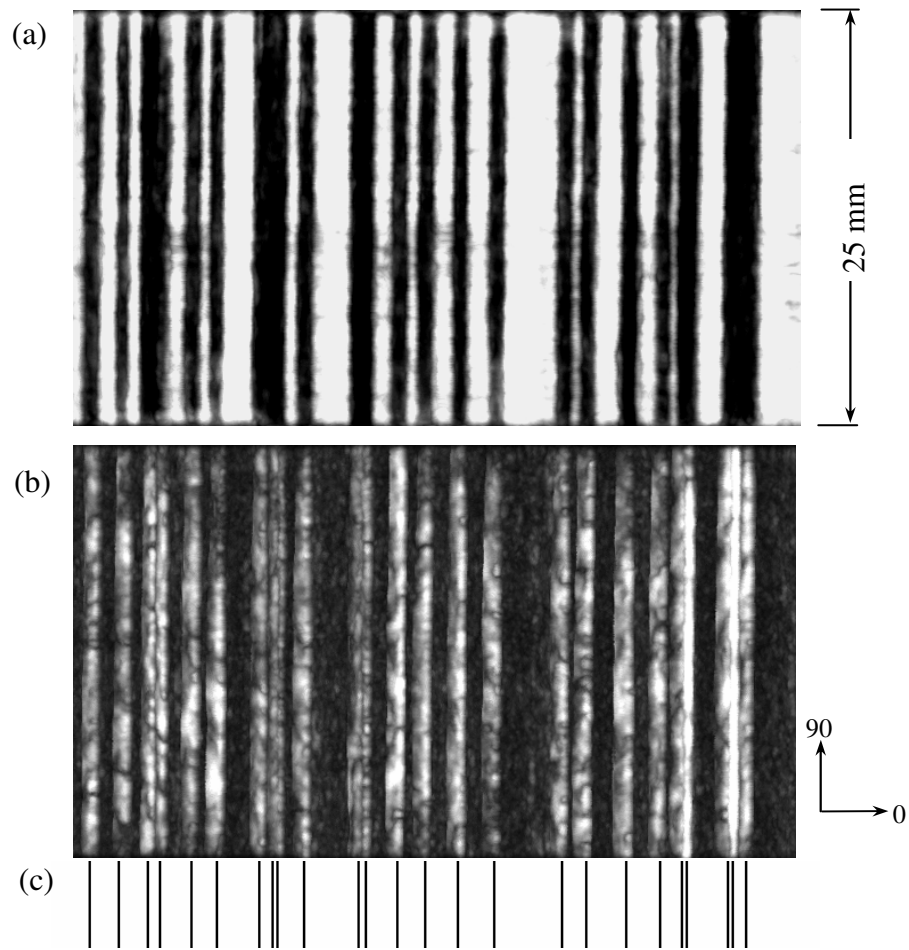
Fig. 2.21 Ultrasonic images of matrix cracks in the $[0/90_3]_s$ CALB-2 laminate. (a) pitch-catch method, (b) polar backscattering, (c) schematic of the optically detected cracks at the edge of the specimen.

In order to guard against fortuitous results, the preceding experiments were repeated on the 8-ply $[0/90_3]_s$ CALB-2 specimen. The laminate was scanned for cracks in the 90_6 ply-group. The results obtained with the pitch-catch and the polar backscattering methods are shown in Figs. 2.21(a) and 2.21(b). A schematic of the optically detected cracks is shown in Fig. 2.21(c). Once again, it is reassuring to obtain a one-to-one correspondence between the two methods for the CALB-2 laminate.

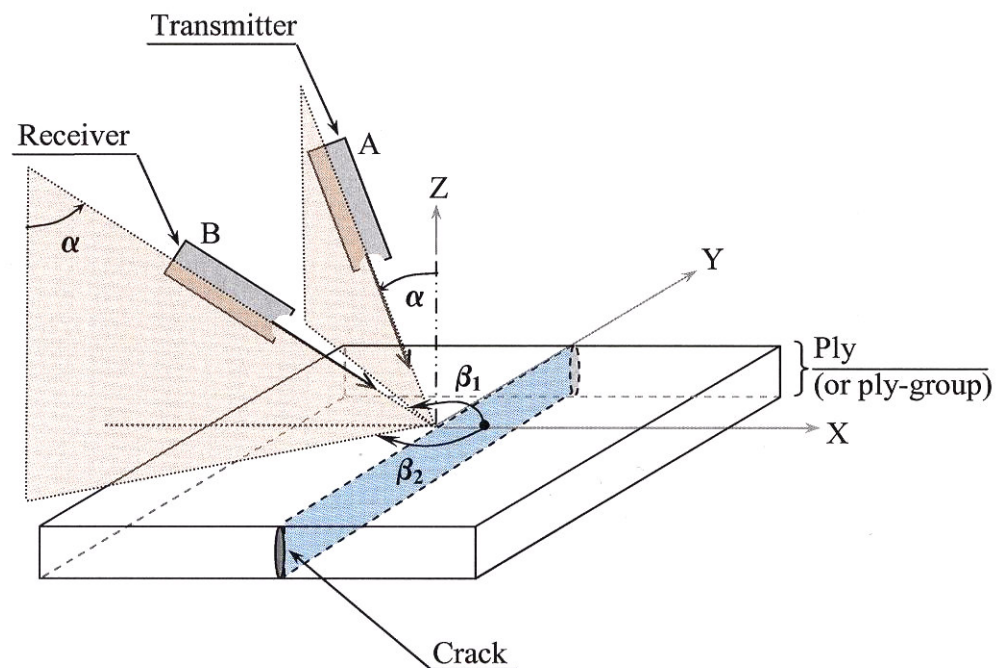
Fig.2.22 A schematic showing the arrangement of the transducers A and B in order that the signal from transducer A is reflected towards transducer B. (The condition that $\beta_1 = \beta_2$ is necessary for transducer B to detect the reflected signal.)

If the received signal is indeed a *specularly reflected* field, then it should follow the basic law of reflection, i.e. the angle of reflection must be equal to the angle of incidence. The second experiment was conducted to ascertain if the received signal indeed followed this law. The same pair of matched focused transducers was arranged in such a way that the crack acts as a reflector of the ultrasonic signal from one transducer towards the other transducer. This arrangement is represented schematically in Fig. 2.22. Transducer A is set as the transmitter, while transducer B is set as the receiver. Both the transducers are inclined at the same angle α to the normal and their position is symmetric with respect to the X-axis (i.e. $\beta_1 = \beta_2$) as seen in Fig. 2.22. The transducers are arranged in such a way as to share the same focal spot (con-focal arrangement). In the absence of a crack, there is no mechanism by which the incident signal may be

reflected towards the receiver. Consequently, the regions without any cracks should appear as dark areas in the image. Whenever a crack is present, it acts as an acoustic mirror and reflects the incident waves towards the receiver B. Thus the cracks should appear as bright bands against a dark field. The results presented in Fig. 2.23(a) for the CALB-1 specimen and in Fig. 2.24(a) for the CALB-2 specimen, show that this is indeed the case. The images were obtained by setting angle of incidence $\alpha = 25^\circ$ and the azimuthal angles $\beta_1 = \beta_2 = 135^\circ$. The polar backscattering images of cracks in the corresponding area for the CALB-1 and the CALB-2 specimens are shown in Figs. 2.23(b) and 2.24(b) respectively. In each case, a one-to-one correspondence is observed between the images obtained by the two methods. These results strongly suggest that the matrix cracks act as ‘acoustic mirrors’ in conjunction with the ply-interfaces and that the backscattered field is in fact a specular reflection of the ultrasonic beam caused by the presence of the cracks.

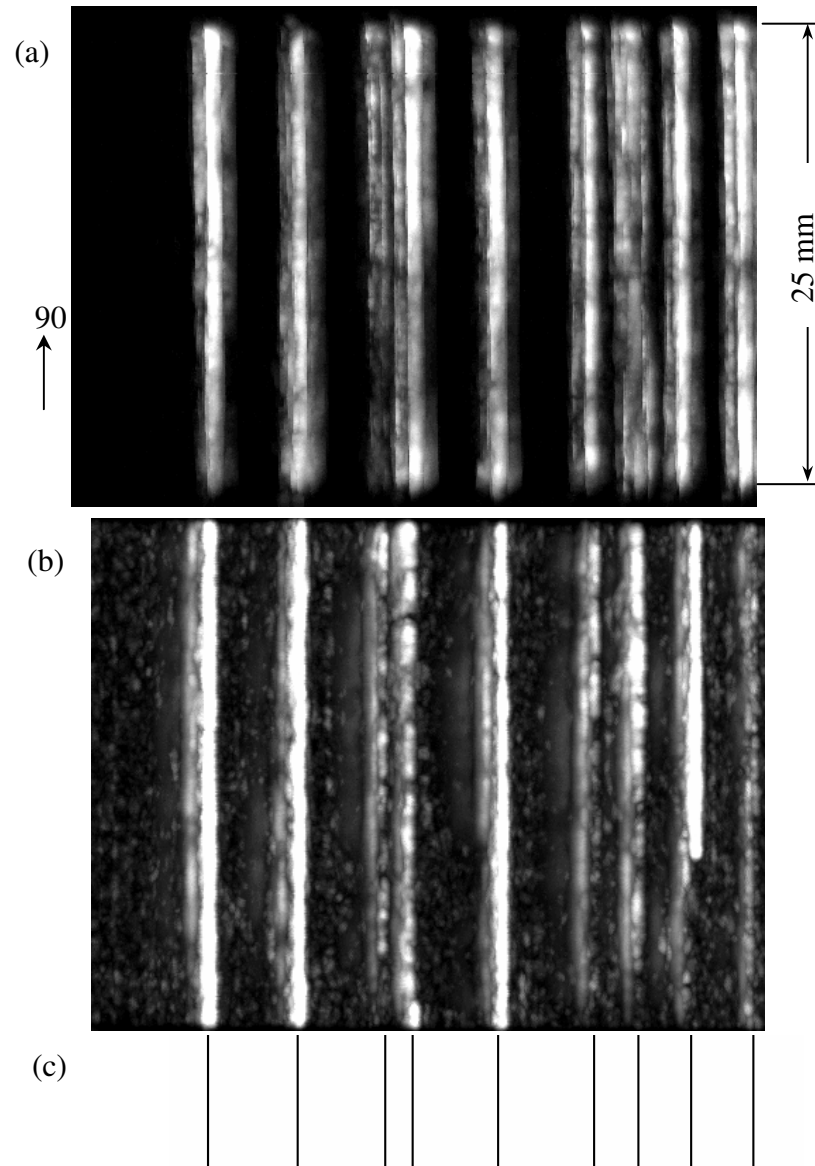
Fig. 2.23 Image of cracks in the 90_8 ply-group of the 10-ply CALB-1 specimen. (a) As obtained by the arrangement shown in Fig. 2.21 ($\alpha = 25^\circ$, $\beta_1 = 135^\circ$, $\beta_2 = 135^\circ$), (b) polar backscattering ($\alpha = 25^\circ$), (c) schematic of the optically detected cracks at the edge of the specimen.

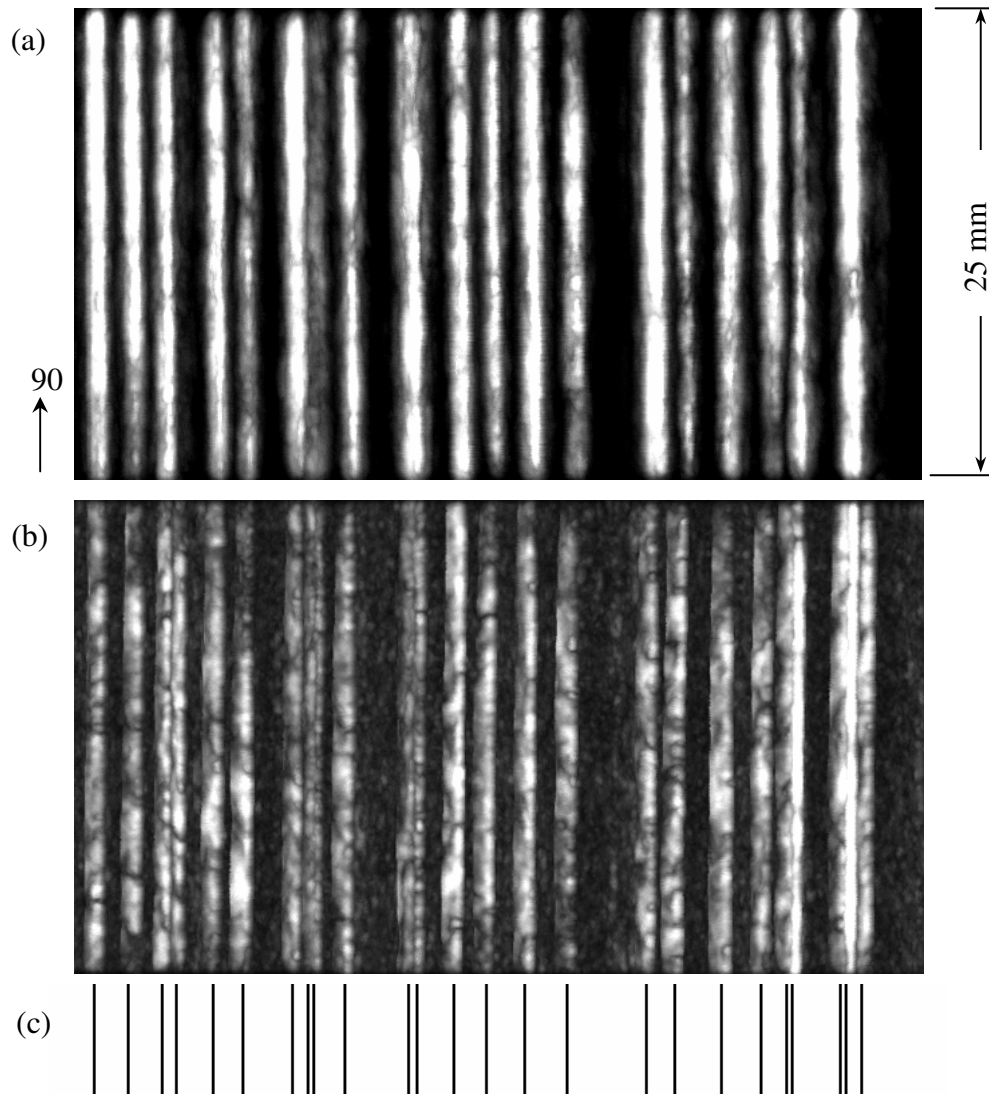
Fig. 2.24 Image of cracks in the 90_6 ply-group of the eight-ply CALB-2 specimen.
 (a) As obtained by the arrangement shown in Fig. 2.21 ($\alpha = 25^\circ$, $\beta_1 = 135^\circ$, $\beta_2 = 135^\circ$),
 (b) polar backscattering ($\alpha = 25^\circ$), (c) schematic of the optically detected cracks at
 the edge of the specimen.

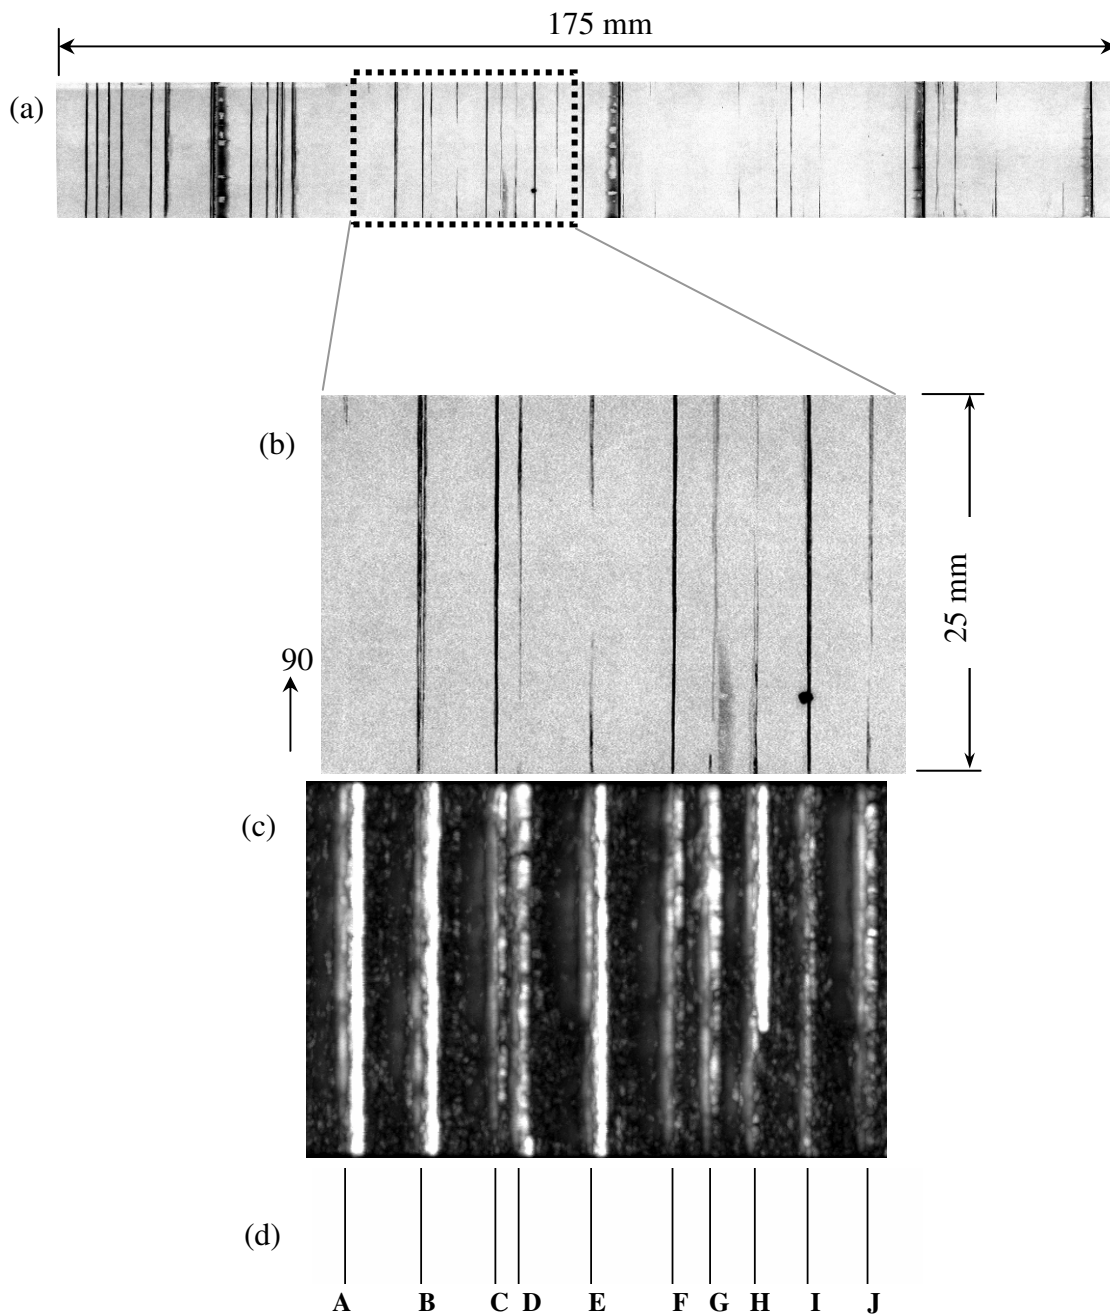
Fig. 2.25 Comparison between the images of the cracks in the 90° ply-group of the CALB-1 laminate as obtained by different techniques. (a) and (b) penetrant enhanced X-ray images, (c) polar backscattering, (d) schematic of the optically detected cracks at the edge of the specimen.

Penetrant enhanced X-ray image of the 10-ply CALB-1 specimen is shown in Fig. 2.25(a). An enlarged view of a section of this specimen, shown by a dotted rectangle in Fig. 2.25(a), is shown in Fig. 2.25(b). The ultrasonic polar backscattering image and the schematic of the cracks detected optically at one of the edges, for the

same area, are shown in Figs. 2.25(c) and 2.25(d) respectively. A one to one correspondence is observed for the cracks detected by optical examination and ultrasonic technique. However, the X-ray image of the same area does not completely show all the cracks. Clearly, the X-ray opaque dye did not successfully penetrate the cracks marked A, D, E, H and J. X-ray image showing cracks in the 8-ply CALB-2 specimen is shown in Fig. 2.26(a). As before, an enlarged view of an area marked by the dotted rectangle in Fig. 2.26(a) is presented in Fig. 2.26(b). For this area, the ultrasonic image and the schematic of the optically detected cracks are shown in Figs. 2.26(c) and 2.26(d) respectively. In this case, the results using the three different techniques corroborate each other well.

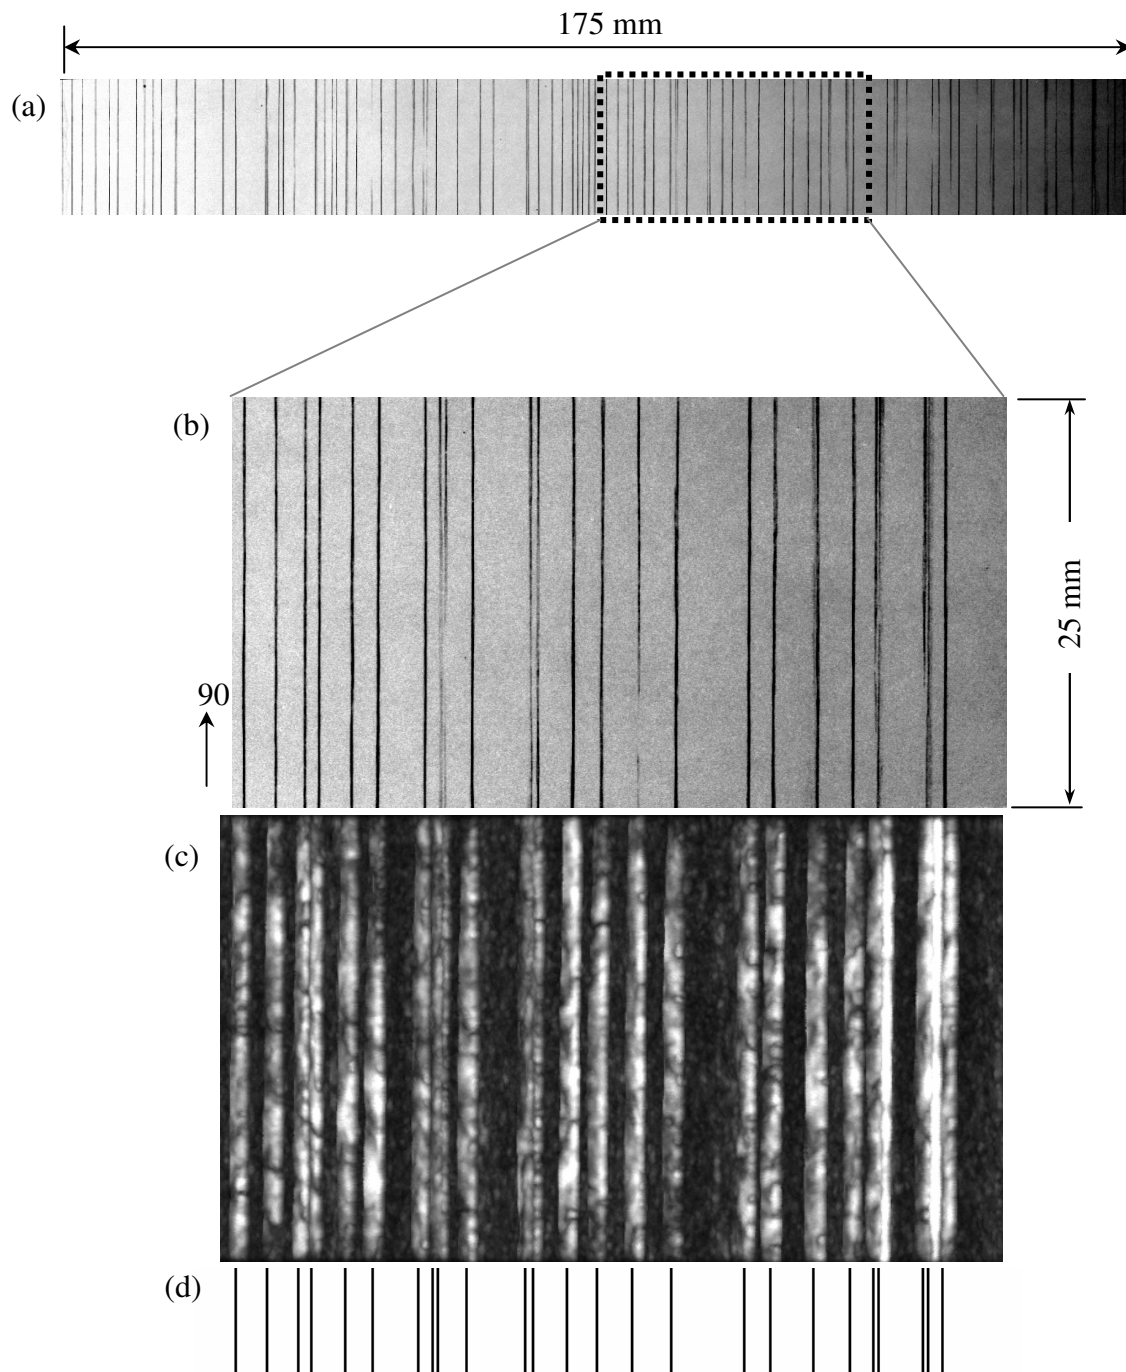
Fig. 2.26 Comparison between the images of the cracks in the 90_6 ply-group of the CALB-2 laminate as obtained by different techniques. (a) and (b) penetrant enhanced X-ray images, (c) polar backscattering, (d) schematic of the optically detected cracks at the edge of the specimen.

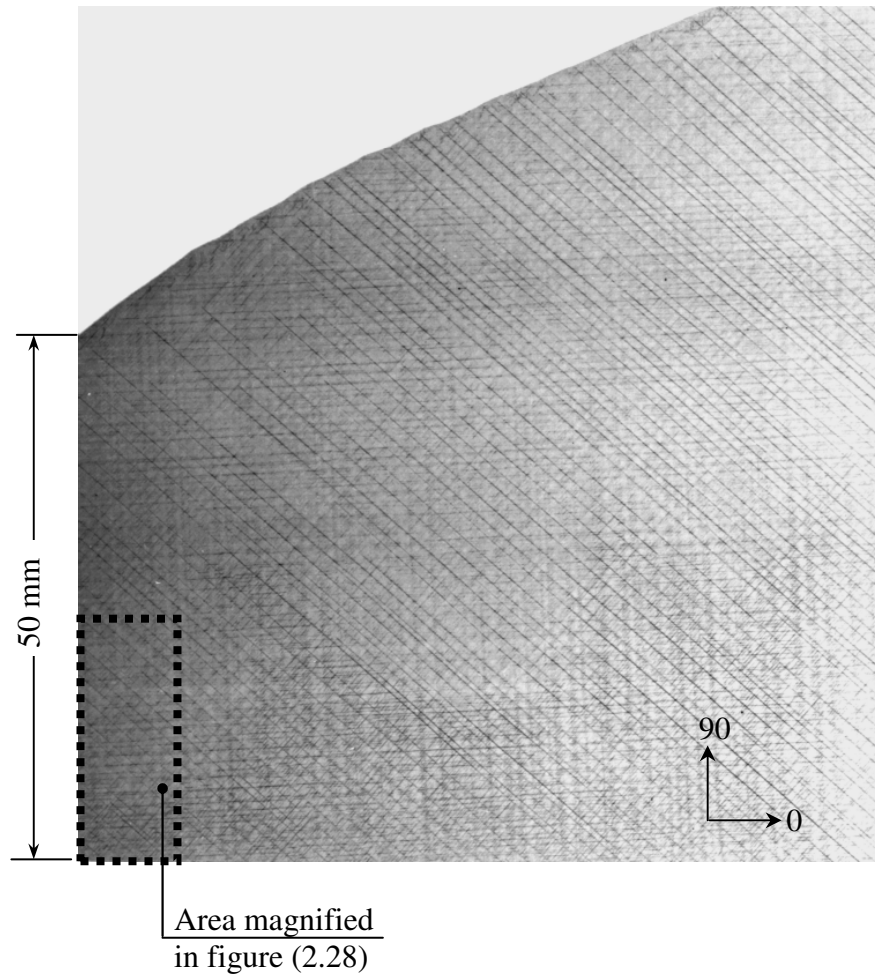
Fig. 2.27 An X-ray image of a part of the eight-ply TAMU-1 specimen showing matrix cracks (dark lines).

A part of the X-ray image of the TAMU-1 (the highly damaged eight-ply $[90/45/0/-45]_s$ laminate), showing cracks in all the plies, is presented in Fig. 2.27. A subsection of this image, marked by dotted rectangle in Fig. 2.27, is magnified and presented in Fig. 2.28. At the bottom and on the left hand side of the Fig. 2.28, a schematic of the *optically detected* edge cracks is plotted. The cracks found in the 90° plies are plotted as vertical lines, cracks found in the 45° plies are plotted as lines at 45° , and so on. As may be seen, a fairly good correlation is observed between the cracks in the X-ray image (dark lines) and the optical image of the matrix cracks. However, the cracks in the 0° , 90° and the 45° directions are not clearly visible in the X-ray image. The highly volatile X-ray opaque penetrant evaporates quickly from the outermost plies (0°), due to which, the cracks in these plies, running in the 0° direction, are not clearly seen in the X-ray image. Optical examination revealed a large number of cracks were at the

Next, for ease of comparison with the ultrasonic data, the X-ray image of the TAMU-1 specimen, shown in Fig. 2.27, was filtered to remove all lines except those corresponding to -45_2 cracks using the standard Kaiser filter with a Hamming window (Details of the filter and the filtering process is beyond the scope of this thesis. Readers may refer to Matlab documentation for the same); the results are presented in Fig. 2.33(a). The ultrasonic image of the cracks in the -45_2 ply-group obtained by polar backscattering method is shown in Fig. 2.33(b). When the image in Fig. 2.33(a) was superimposed on the image of Fig. 2.33(b) on a computer screen, an excellent (virtually a one-to-one) correspondence was observed. The comparison was better than can be seen in the printed version because some information is inevitably lost in going from the computer screen image to the printed version. A similar comparison was made between the filtered X-ray images and the ultrasonic images of cracks in the -45_2 ply-group of the TAMU-2, TAMU-3 and the TAMU-4 specimens. The X-ray and the ultrasonic images of the TAMU-2 specimen are presented in Figs. 2.34(a) and 2.34(b) respectively; for the TAMU-3 specimen the corresponding images are shown in Figs. 2.35(a) and

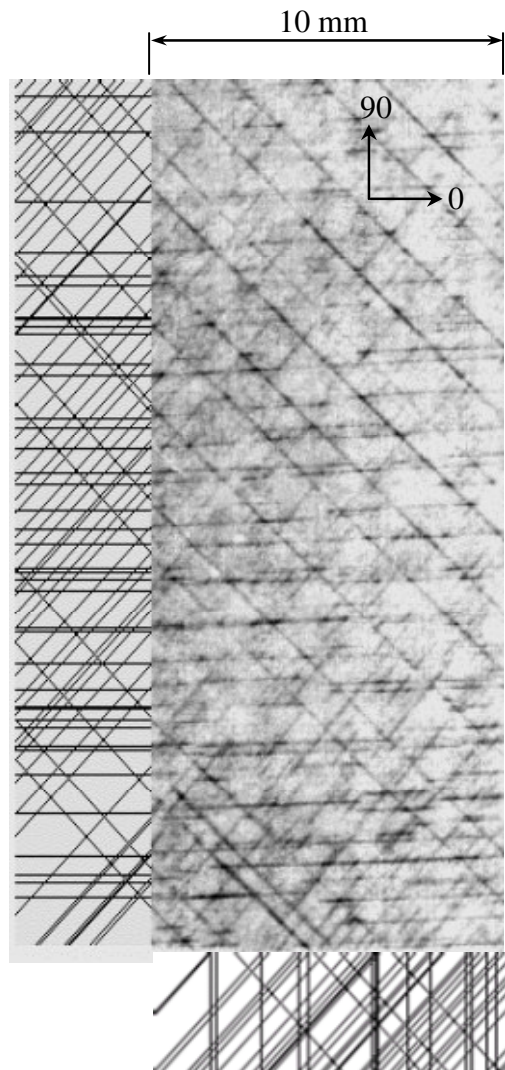
Fig. 2.28 A comparison of a part of the X-ray image of the TAMU-1 laminate with the schematic of the optically detected matrix cracks.

edges of the second (45°), third (90°), sixth (90°) and the seventh (45°) plies. This was because of the presence of a high density of short cracks in these plies. A detailed discussion of short cracks is deferred to Chapter III. The short cracks are not clearly visible in the X-ray image shown in Fig. 2.28. This explains the lack of good correlation between the X-ray image and the schematic of the optically detected cracks in the 45° and the 90° directions.
